ANNUAL REPORT FOR 2011

**Bald Creek Site #3 Mitigation Site
Yancey County
TIP No. R-2518B**

Prepared By:
Natural Environment Unit & Roadside Environmental Unit
North Carolina Department of Transportation
December 2011

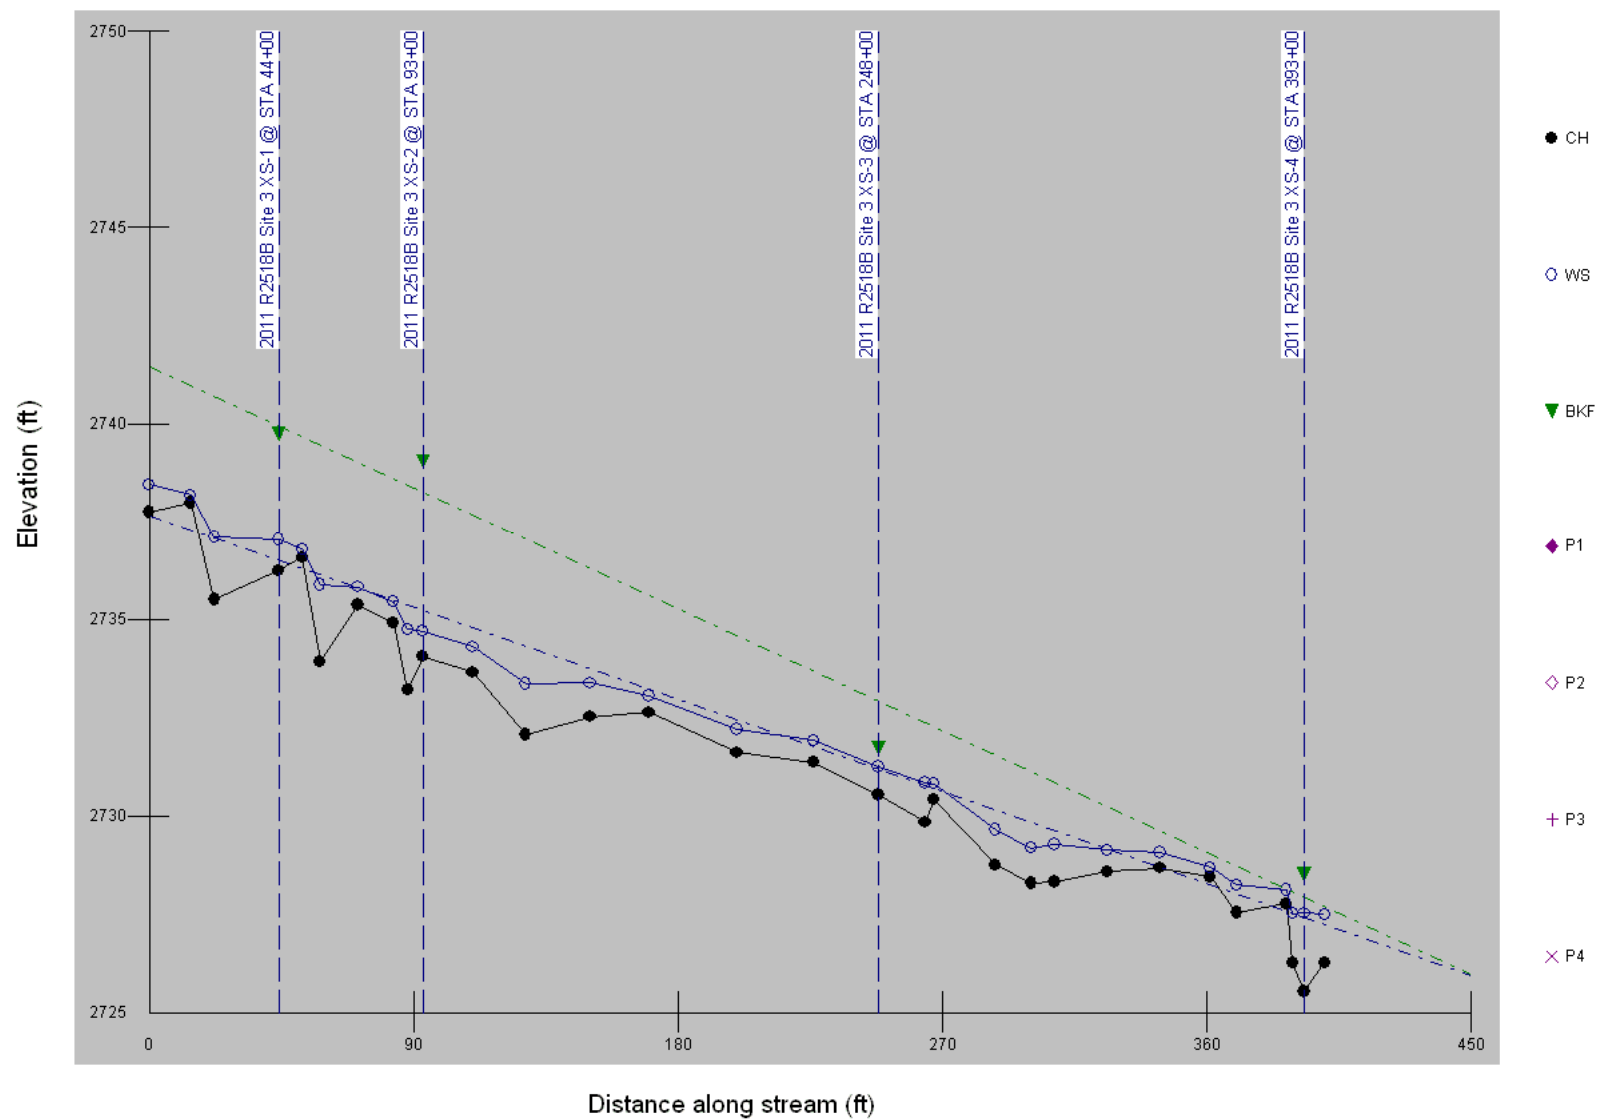
2011 R-2518B Site 3 Profile

Based on comparisons of the As-Built to the monitoring data, all of the cross sections appear stable with little or no active bank erosion. Graphs of the cross sections are presented in Appendix A. Future survey data will vary depending on actual location of rod placement and alignment; however, this information should remain similar in appearance. The longitudinal profile showed that the channel was stable for the 2011 monitoring evaluation. Pebble counts were not required per the permit conditions and therefore were not completed.
